Comments on NIST NCSTAR 1 Draft

July 27, 2005

James Quintiere, Prof
Fire Protection Engineering
University of Maryland
College Park, MD 20742
jimq@umd.edu

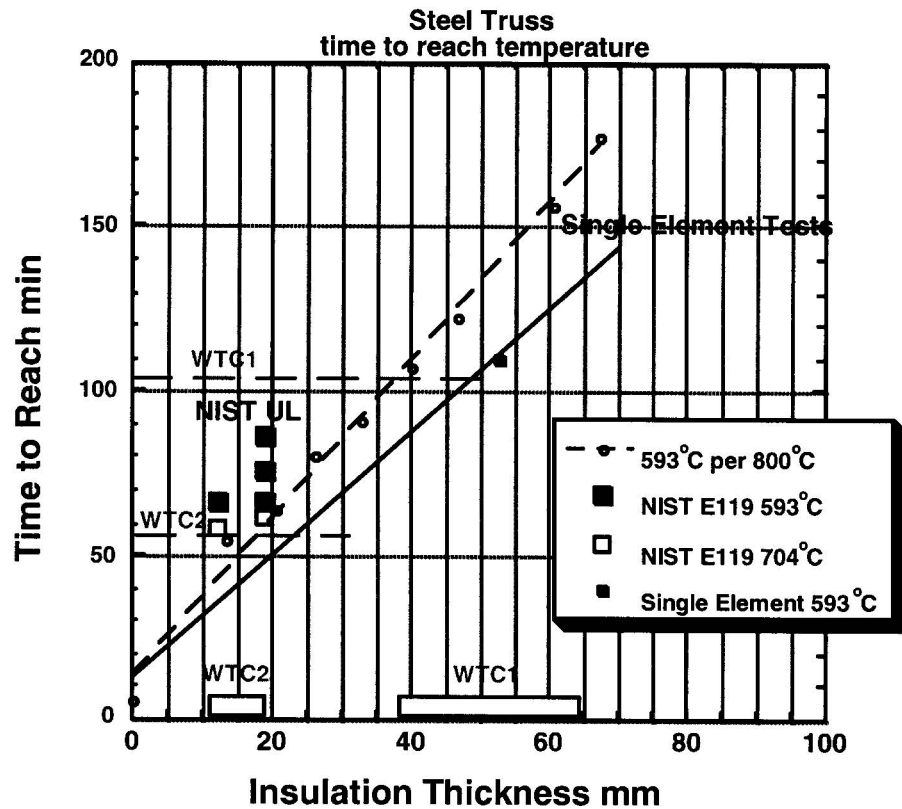
Figure 1. UL and Isolatek results.

It is noted that the predicted times to reach the critical failure temperature of the truss steel of 55 -73 minutes for WTC 2 and 111 minutes for WTC 1 in Table 1 is consistent with the building collapse times of 56 and 102 minutes, respectively. These predicted heating times are also consistent with the NIST measured heating times (to 66 to 86 minutes, although the reduced scale 17 ft span tests compromised heat transfer) in the UL furnace tests at fire temperatures comparable to 800 °C shown in Table 2 taken from NIST. Indeed, the UL time to reach 1100 °F (593 °C) for the 35 ft span ranges from 66 to t6 minutes which is consistent with 73 minutes in Table 1 and an extrapolated time of 50 minutes for the UL temperature conditions. (See Figure 1.)

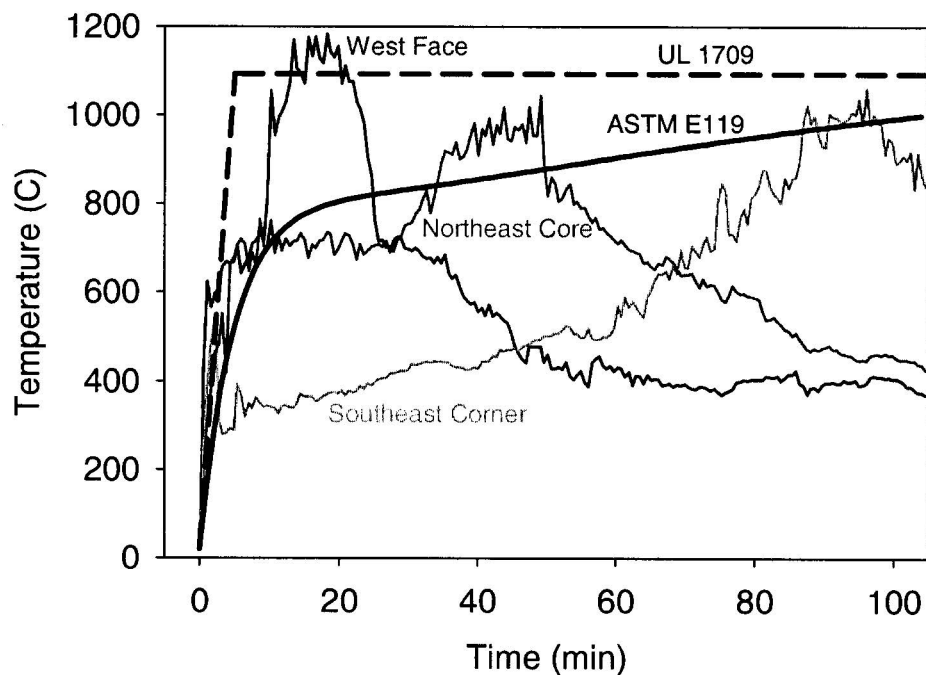
Figure 2. Predicted upper layer temperatures at various locations on the 97[th] Floor.

The results of the NIST fire predictions are based on a fuel loading of 4-5 psf. These levels are based on data from the impacted floors of Marsh & McLennan in WTC 1. NIST says this has "high" accuracy [p 119]. They find for WTC 1 that a given floor did not have uniform temperatures. "At any given location, the duration of temperatures near 1,000 °C was about 15 min to 20 min." [p 127] Upper layer temperatures are shown in Figure 2 for WTC 1 97[th] floor [NIST]. Temperatures generally exceeded 600°C for about 30 minutes, and for about 60 minutes in the core. In contrast, a scale model test conducted at the University of Maryland, representative of the 96[th] floor with a simulated fuel load of 11.5 psf, shown in Figure 3 indicates temperatures are generally over 6000C for 100 minutes, by are much cooler in the core. These results are distinctly different from the NIST simulation. One may be dubious of scale modeling, but it is a tried and true technique.

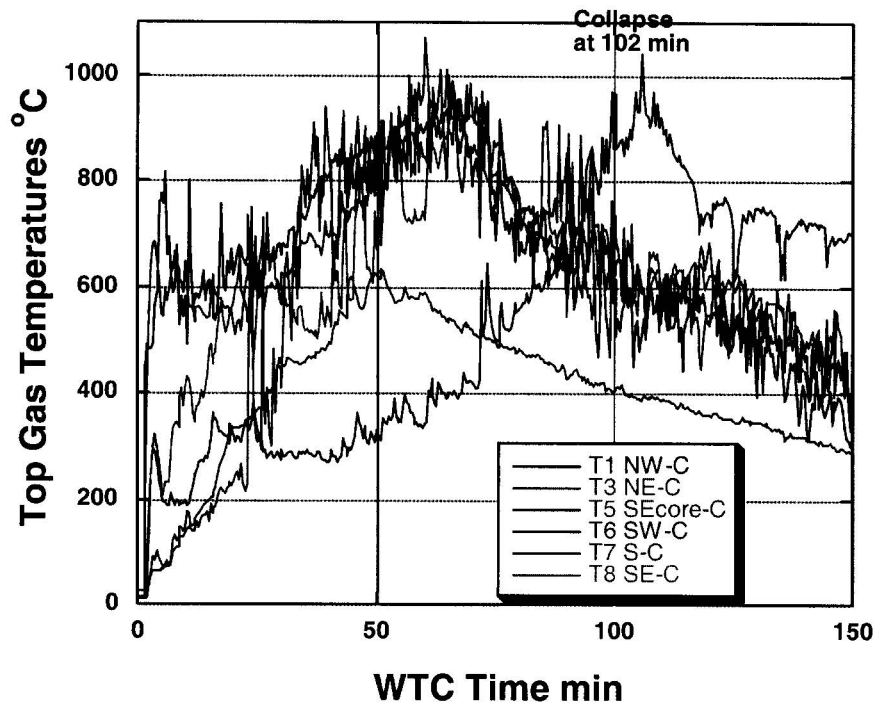
Figure 3. Temperatures in a scale model of WTC 1 96th floor

The heavier fuel load in the scale model was based on traditional office loadings and on anecdotal interviews of people familiar with the floors. Subsequently, we conducted a fuel load survey of the 96th floor based on architectural plans obtained from the furniture installer. This led to a conclusion that a loading of 10 psf or greater was the case. Appendix C contains the details in a report. Figure 4 shows a section of the architectural plans used for the 96th floor. A handwritten notation indicates a section of common files that ringed the core of the office space. There were 170 of these 4-drawer lateral files. NIST completely ignored this fuel load (and others) in their assessment. We assigned 100 lbs of paper per draw (a sub-capacity level) giving 68,000 lbs for this contribution. In addition, there were other common files and a storage room that gave a grand total of 95,400 lbs not included by NIST. In the survey conducted by Kate Stewart, estimates of paper and personal items were included in the workstation loads based on typical office conditions. Our total floor combustible loading was estimated at 302,062 lbs

compared to 134,640 lbs determined by NIST. Taken over the office floor space area (31,013 ft^2), this computes to 9.7 psf and 4.3 psf for NIST. Our paper extimat per file draw is well below

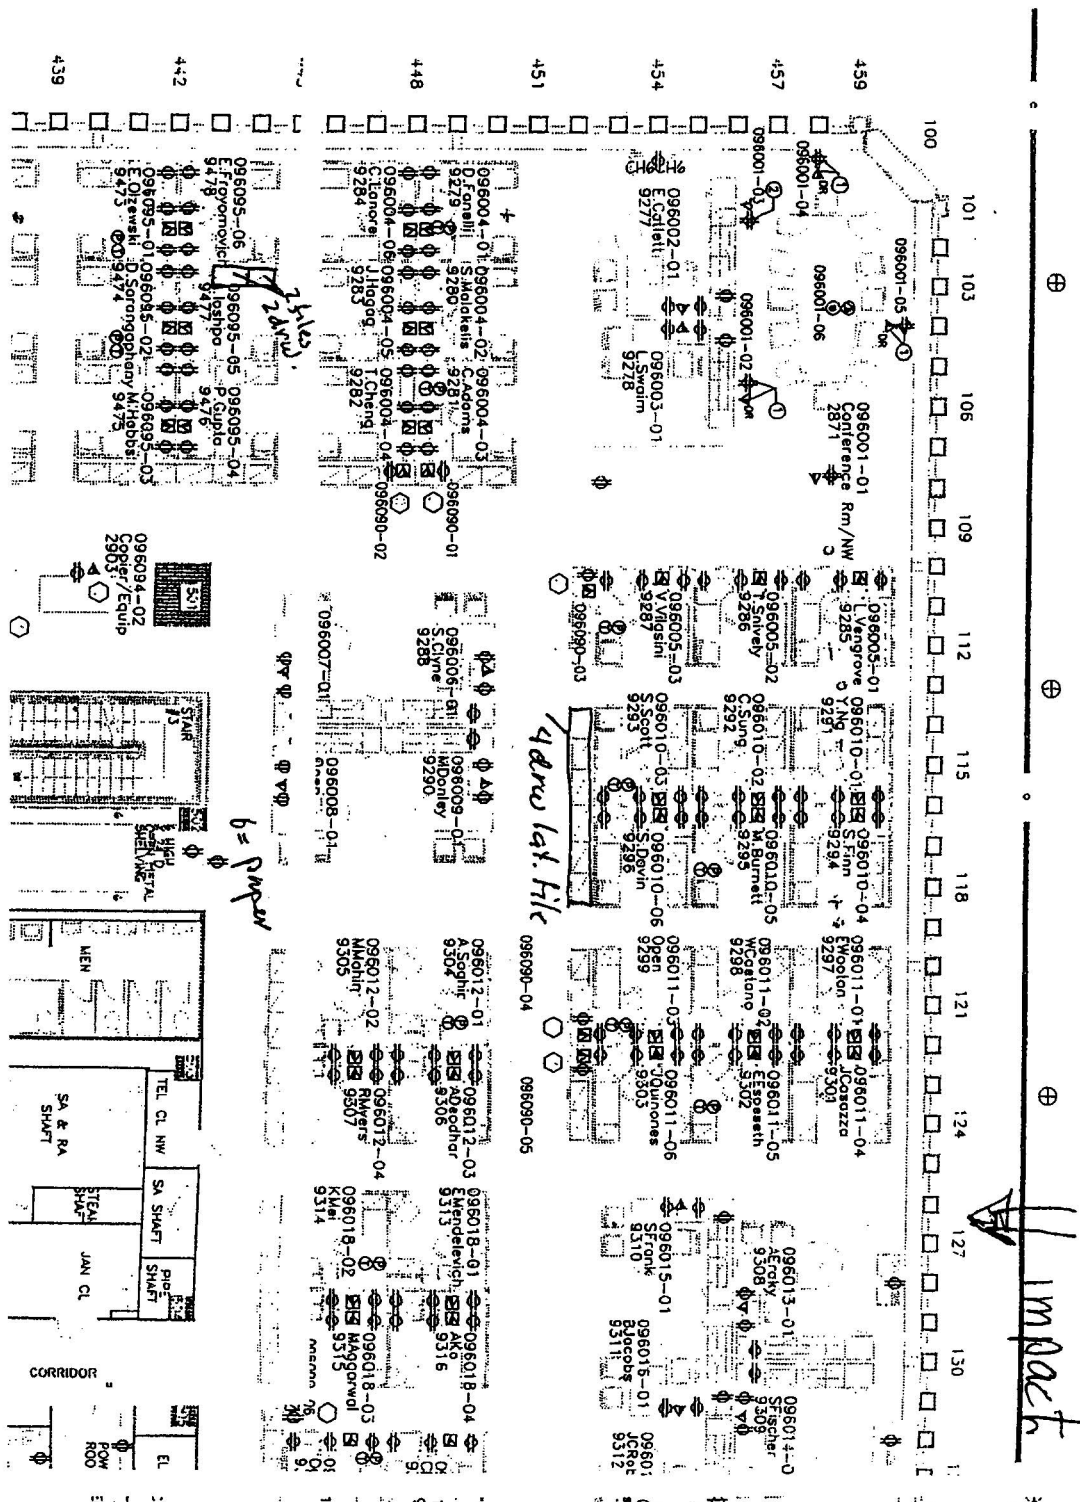
Figure 4. Section of furniture layout WTC 1 96th floor

capacity, so the loading we determine is likely too low. Indeed, it was told to us that Marsh was a "paper hog" and "kept everything". Paper fuel in closed files is de-rated in fire design considerations, but the aircraft impact could have opened the file draws.

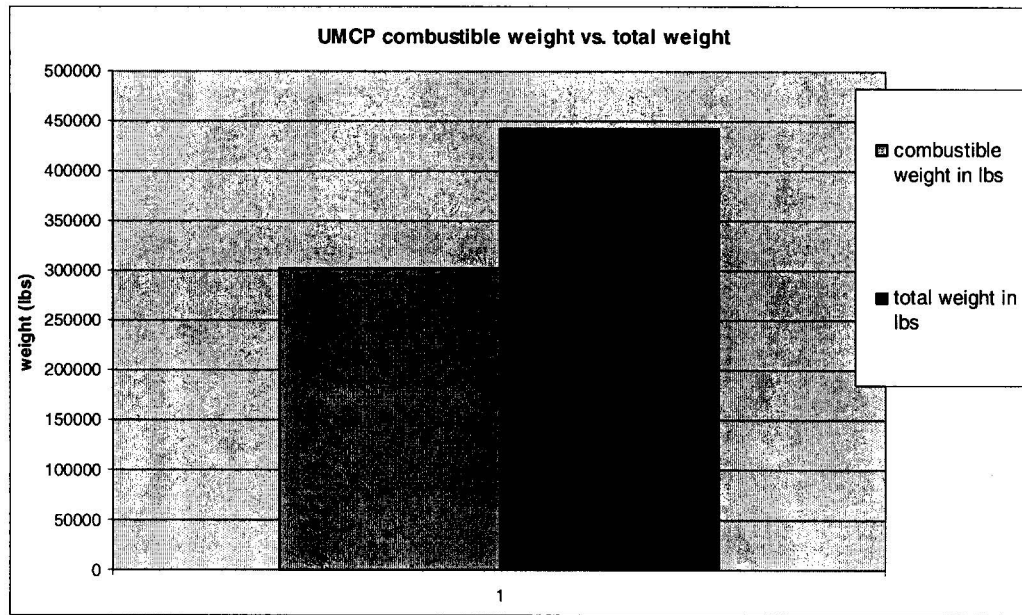
Figure 1. UMCP estimate of how the total workstation weight is distributed.

- ❑ The following are graphical representations of the difference between the paper weight not included (NIST) and the total weight inclusion (UMCP):
